OHIO RIVER BASIN,
JACOBS CREEK, WESTMORELAND COUNTY, Pennsylvania

PA-657 DAM
(ACME DAM)

PHASE I INSPECTION REPORT,
NATIONAL DAM INSPECTION PROGRAM

Owner: Westmoreland County Commissioners
State Located: Pennsylvania
County Located: Westmoreland
Stream: Jacobs Creek
Inspection Date: 4 May 1979
Inspection Team: GAI Consultants, Inc.
570 Beatty Road
Monroeville, Pennsylvania 15146

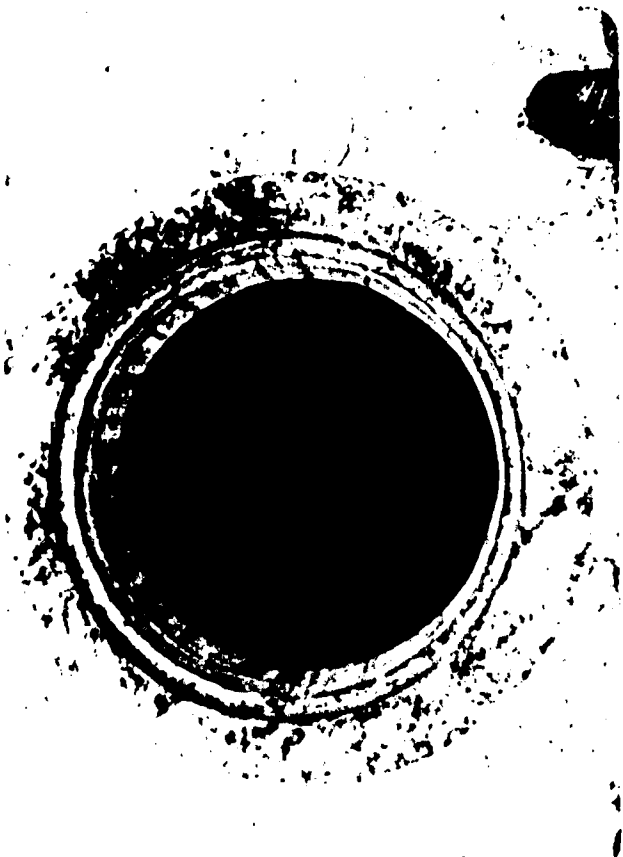
PHOTOGRAPH 5

View through the manhole opening of the interior of the service spillway riser. The manhole cover was missing on the day of the inspection.

a. Repair the damaged pond drain gate control and replace the missing manhole cover atop the service spillway riser. Consideration should be given to redesigning the gate control mechanism to protect it from future vandalism.
